**UNITED STATES DISTRICT COURT  
MIDDLE DISTRICT OF FLORIDA  
ORLANDO DIVISION**

**Case No. 6:24-cv-693-JA-LHP**

**MEMORANDUM DECISION AND ORDER**

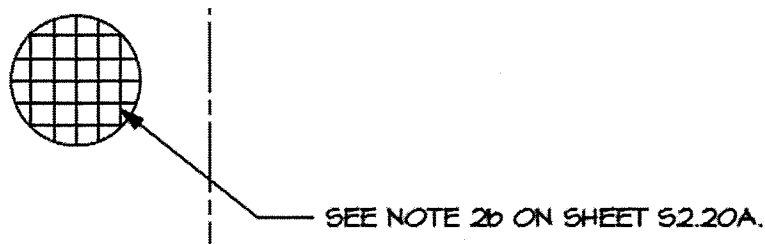
The original floor framing plan for Level 2, Area B, depicted the structural

layout of the floor of Level 2 and included, near the center, a graphic with a note:

(Original Sheet 2.20B, HKS Ex. 13 at 2). As explained by Orlando Health's engineering expert, Webb Wright of Walter P Moore, this "circle with a grid pattern" graphically represented reinforcing steel for the slab in a mat configuration. (Tr. at 335 (Wright Test.)). And the note pointing at the circle directed the contractor to Note 2b on Sheet 2.20A<sup>12</sup> "for information on the reinforcement that's specified for the slab." (Tr. at 335 (Wright Test.)).

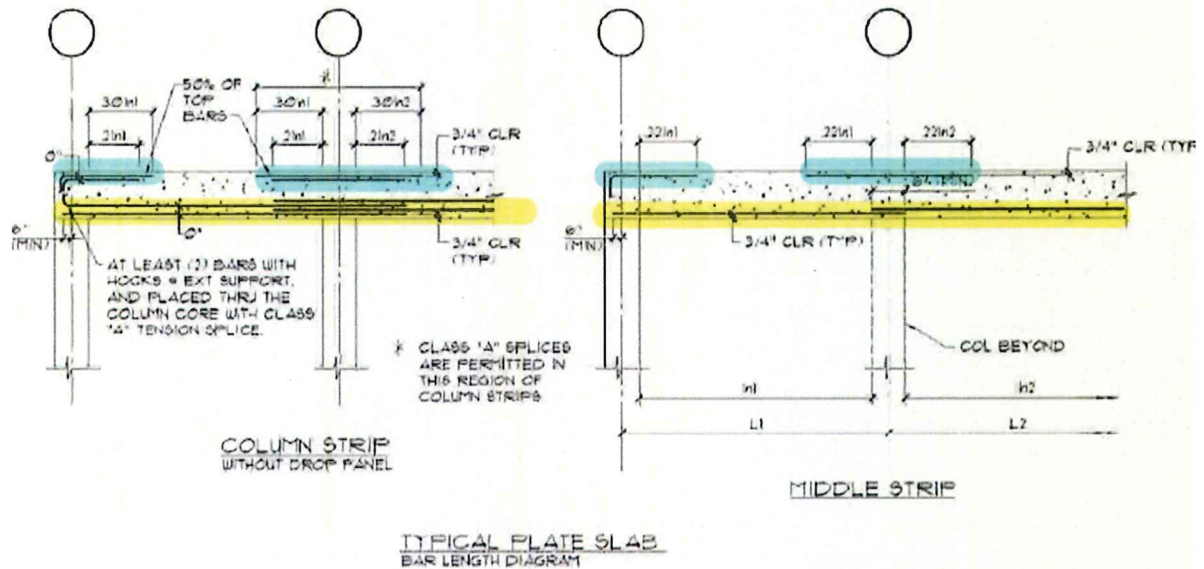
“Sheet S6.02 for rebar placement details for flat slab.” The original Sheet S6.02 included the following “Typical Plate Slab” details showing various conditions:

(Original Sheet S6.02, OH Ex. 37 at 4<sup>15</sup> (emphasis added)).<sup>16</sup> Top bars are highlighted in blue here and bottom bars are highlighted in yellow. It is undisputed that the top bars are discontinuous in these drawings and that “continuous bottom reinforcement at the bottom of the slab” is depicted. (See, e.g., Tr. at 341–42 (Wright Test.); see also Tr. at 117–18 (Walsh Test.)). Walsh testified that the top bars on this original Sheet S6.02 only extended about 24–30 inches from the column; in a 30-foot by 30-foot slab area, there was an area 25 feet by 25 feet in the middle that was “devoid” of top bar. (Tr. at 119 (Walsh

At trial, Erbilien admitted to these flaws in the “plate slab” details on BBM’s original Sheet S6.02. He acknowledged that these details did not show “top mat,” (Tr. at 766–68 (Erbilen Test.)), and instead only showed some “top bars,” (Tr. at 768 (Erbilen Test.)). In fact, Erbilien explained that BBM put this original S6.02 drawing sheet in the plans by “mistake”; BBM erroneously “provided the traditional . . . detailing” for an 8-inch slab, which has only one layer of continuous rebar—a bottom mat. (Tr. at 767 (Erbilen Test.); *see also id.* at 765). Erbilien explained that “in a 8-inch-thick slab, . . . the top bars are not as a mat [but are] top bars that are a specific length that are placed around columns.” (Tr. at 767 (Erbilen Test.)). Original Sheet S6.02 thus incorrectly “depicted a traditional 8-inch-thick slab,” and Erbilien agreed BBM “should have used a 10-inch-thick or thicker slab detail,” (Tr. at 764 (Erbilen Test.)).
